## Lead Cable Investigation

June 01, 2023

MTS traveled to the agreed upon locations and surrounding communities with the WSJ to investigate the permit locations for presence of lead sheathed cables. Documentation as to the presence and condition of the lead sheathed cables was collected at each identified location using Fulcrum, data management software provided by Below the Blue (BtB), a not-for-profit organization.

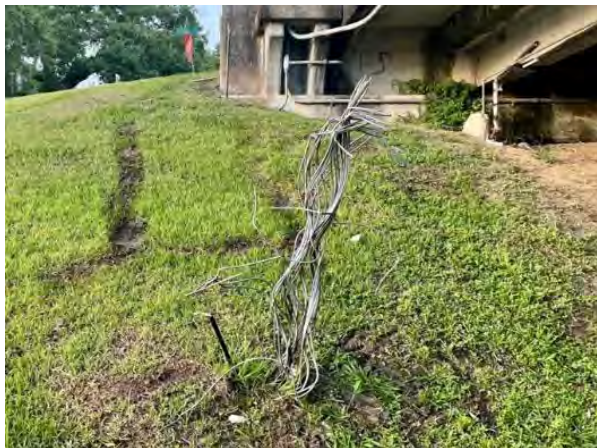
(A) Remnants of bare leaded cable and steel wire below the Bridge Street Bridge. BT 1.1. June 2022, New Iberia, Louisiana.

Twelve points of interest along the Bayou Teche contained visible leaded cables, with both power and telecommunication cables at various locations. BT 1.1 was the first point of interest at this location; five feet of steel wire were observed protruding from the ground with a portion of damaged, bare leaded cable at the base [Figure 2](#)~~Figure 2~~. Further along the Bayou Teche, BT 16.1 illustrated a sort of debris field that would end up characterizing much of the area, a combination of new and old materials left in varying conditions and states of use ([Figure 2](#)~~Figure 2~~[Figure 2B](#)). BT 17.1 contained four leaded cables underneath the bridge: two power cables and one telecommunication cable. Sections of bare lead were observed near the water's surface ([Figure 2](#)~~Figure 2~~[Figure 2C](#)). Along the E. Bridge Street bridge in the historic district of St. Martinville, LA, BT 24.1 contained the first leaded splice box observed and was located along the sidewalk going into town ([Figure 2](#)~~Figure 2~~ and [Figure 3](#)~~Figure 3~~[Figure 3E](#)). This location also had a Bell Systems manhole. In Franklin, LA at Location BT 26.2, another exposed lead splice box and set of cables were observed in a small muddy duck pond in a public park with direct drainage into the Bayou Teche ([Figure 3](#)~~Figure 3~~[Figure 3E](#)).

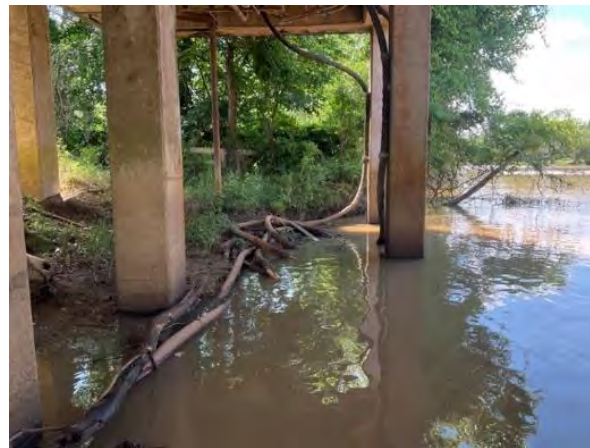
(C) Rd. 320 southeast of New Iberia, LA. Cluster of leaded cables under the Oliver Bridge. BT 17.1. June 2022, New Iberia, Louisiana.

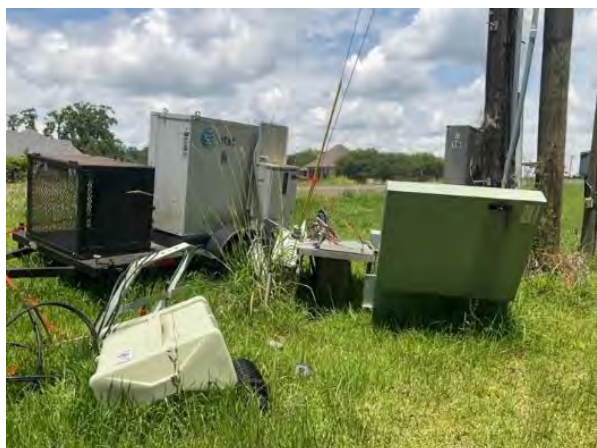
(B) Equipment debris field left by workers near the N Lewis Street Bridge. BT 16.1 June 2022, New Iberia, Louisiana.

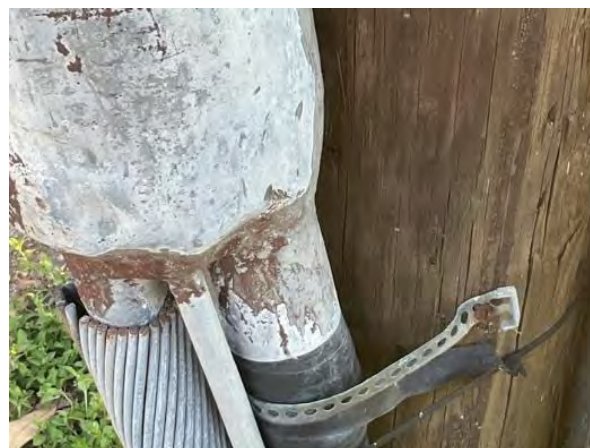
(D) Up close photo of bare leaded cables going into a lead splice box. BT 24.1. June 2022, St. Martinville, Louisiana.

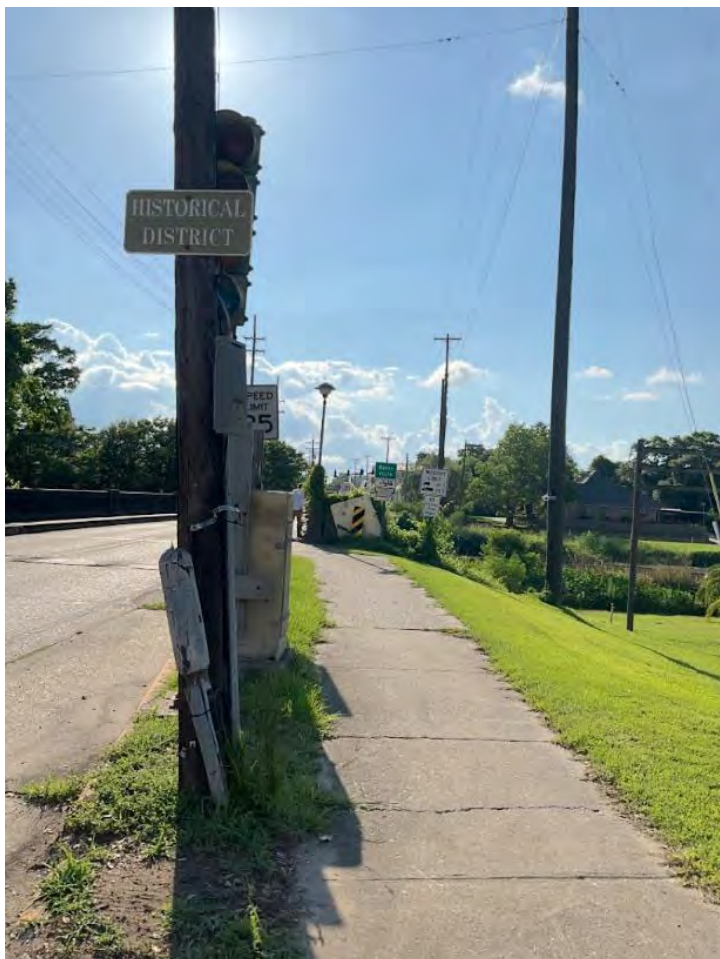
(E) Bare leaded cables going into a lead splice box near the sidewalk leading into the Historical District. BT 24.1. June 2022, St Martinville, Louisiana.

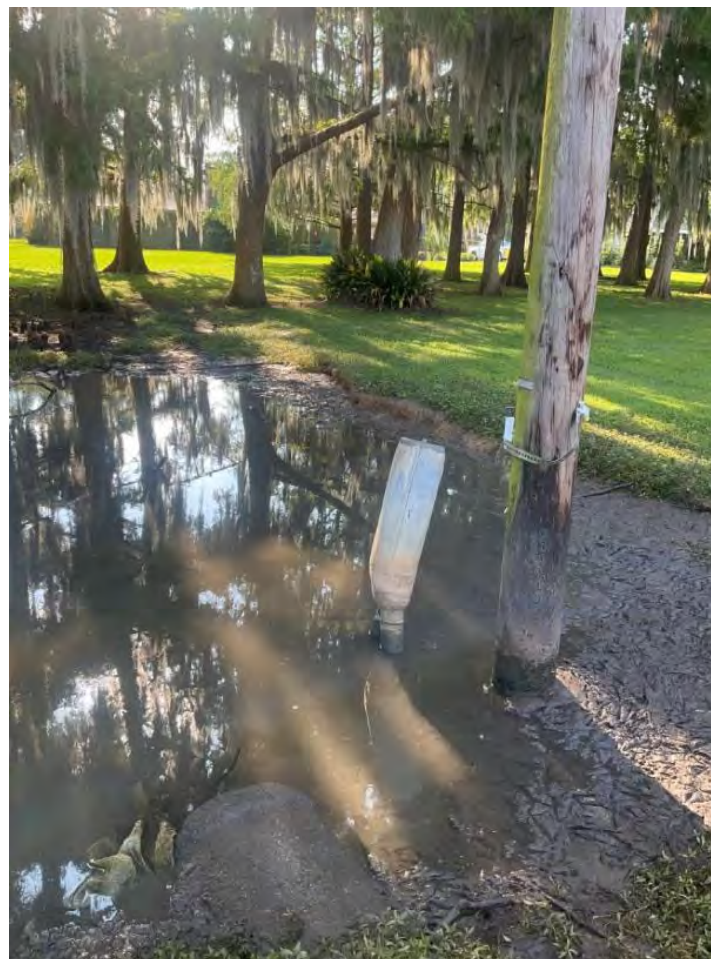
(F) Exposed lead splice box with attached cables and drainage into the Bayou Teche. BT 26.2. June 2022, Franklin, Louisiana.

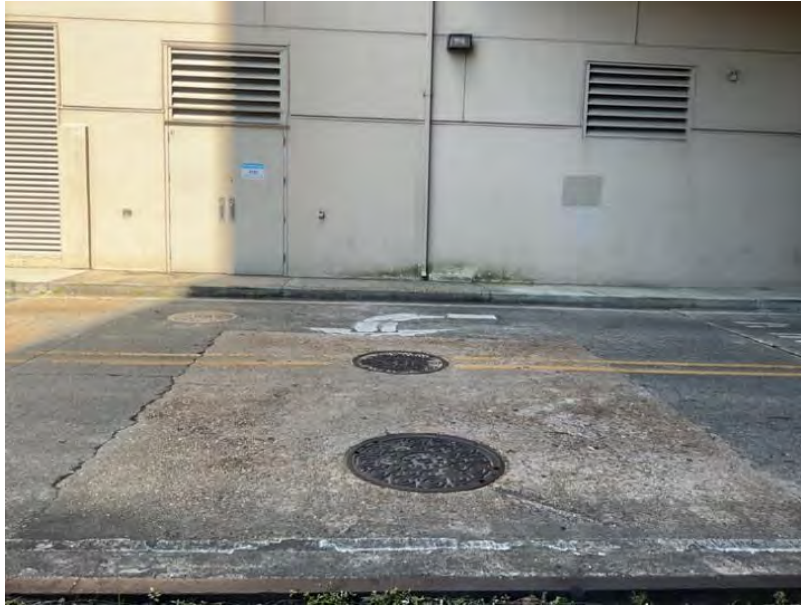
(G) New Orleans, LA. MISS 2.1 with Bell Systems manholes, vault, and Utility Building. This is a likely hub and splice area for cables, both old and new. June 2022.

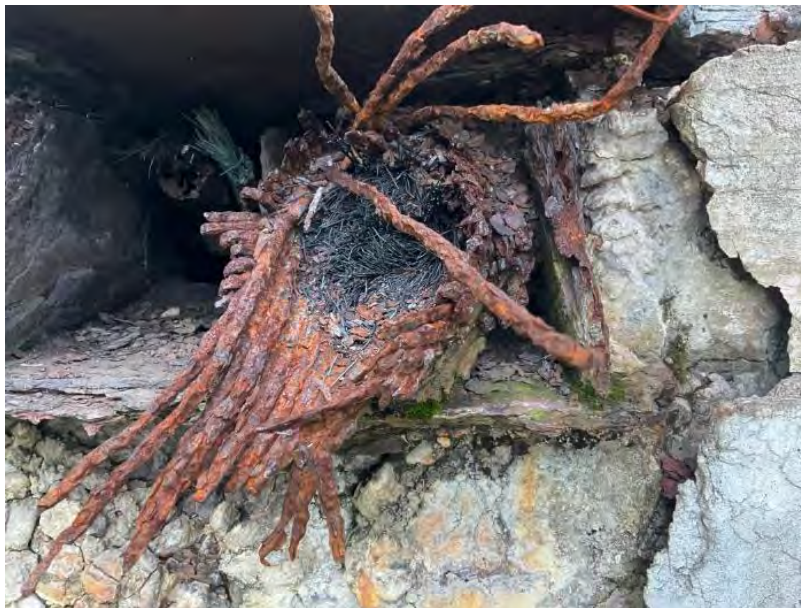
(H) New Orleans, LA. MISS 3.1. is an abandoned collection of cables. This site is a known homeless hangout.

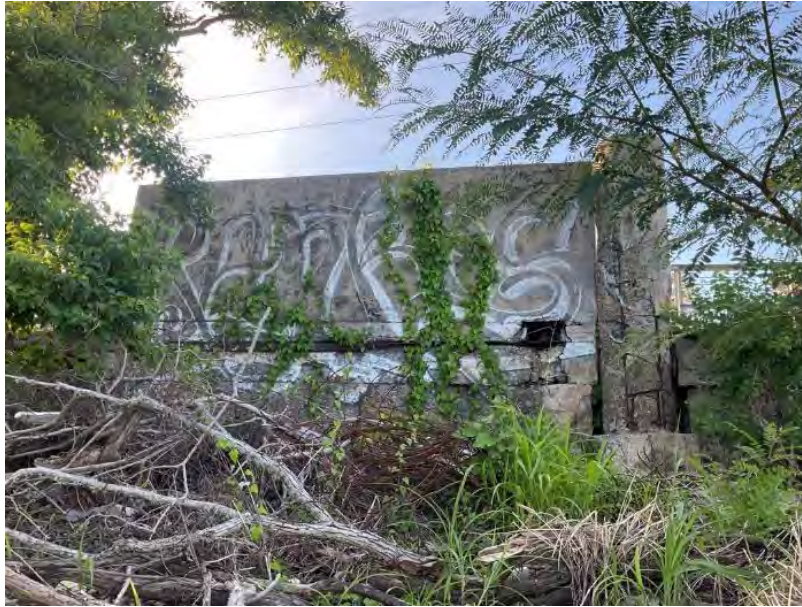
(I) New Orleans, LA. MISS 3.1. The small rectangle on the left is the passthrough for utility cables. June 2022.

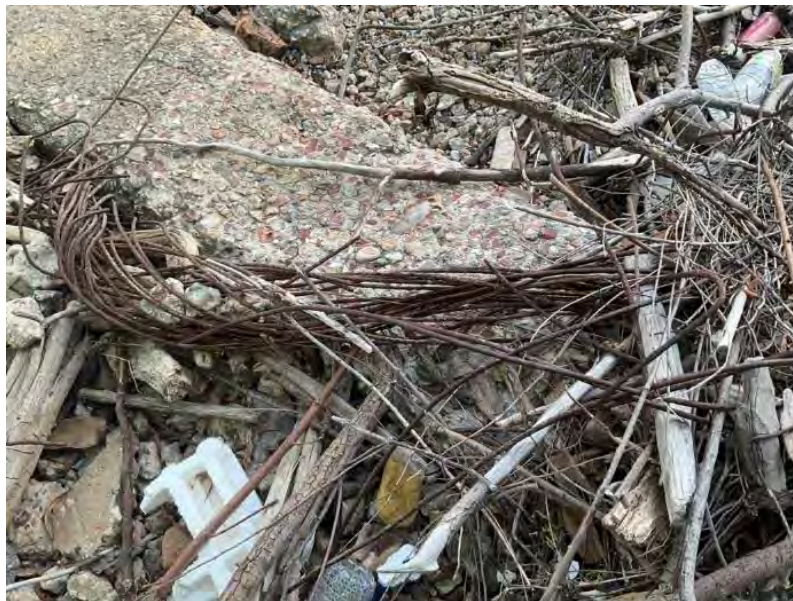
(J) New Orleans, LA. MISS 3.1. Remnants of outer steel wire from a leaded cable. Evidence that parts of the cable may have been scrapped for money. Locals told us that that was done to these cables.

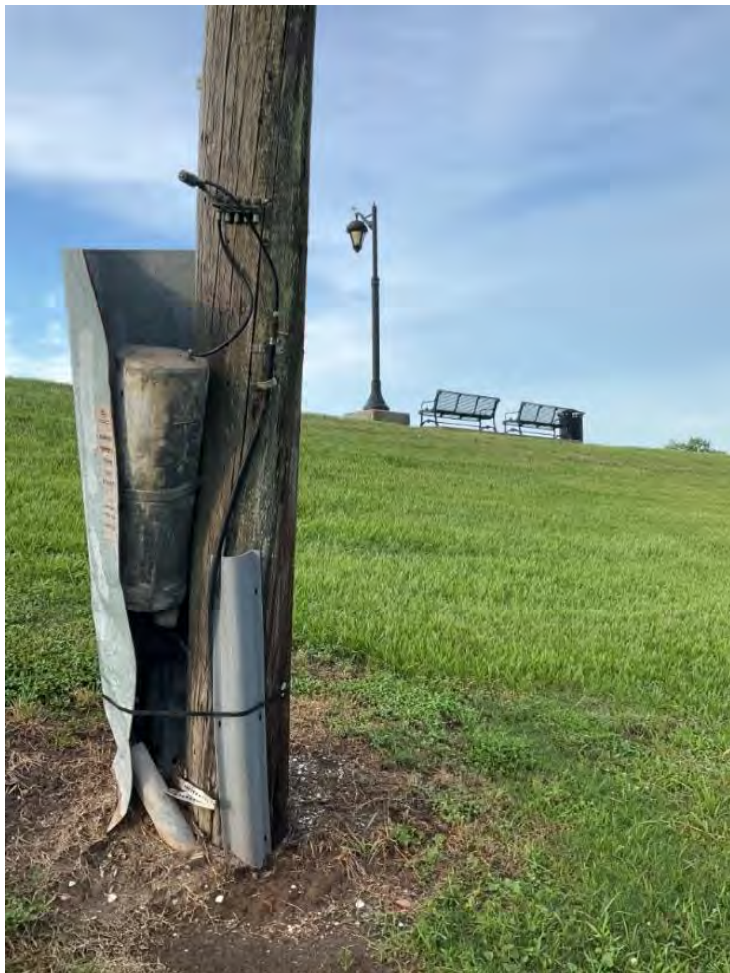
(K) Donaldsonville, LA. Location MISS 12.1. Exposed leaded splice box that appears to still be connected to an air test line. See photo (L) for the abandoned cable just the other side of the splice box. June 2022,

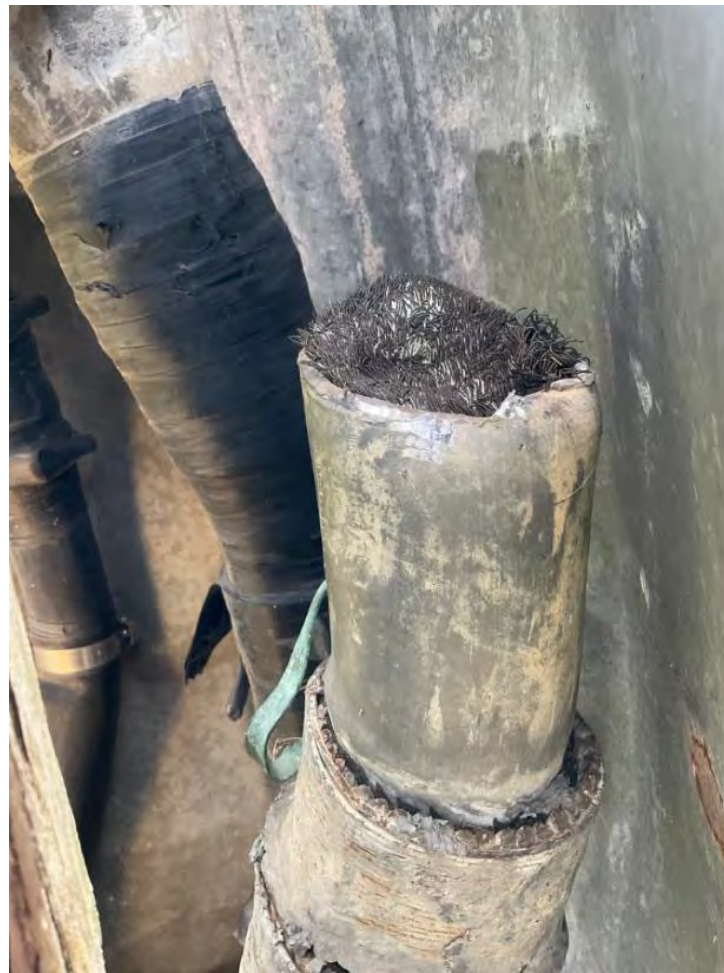
(L) Donaldsonville, LA. Location MISS 12.1. Close up of leaded cable next to lead splice box. June 2022.

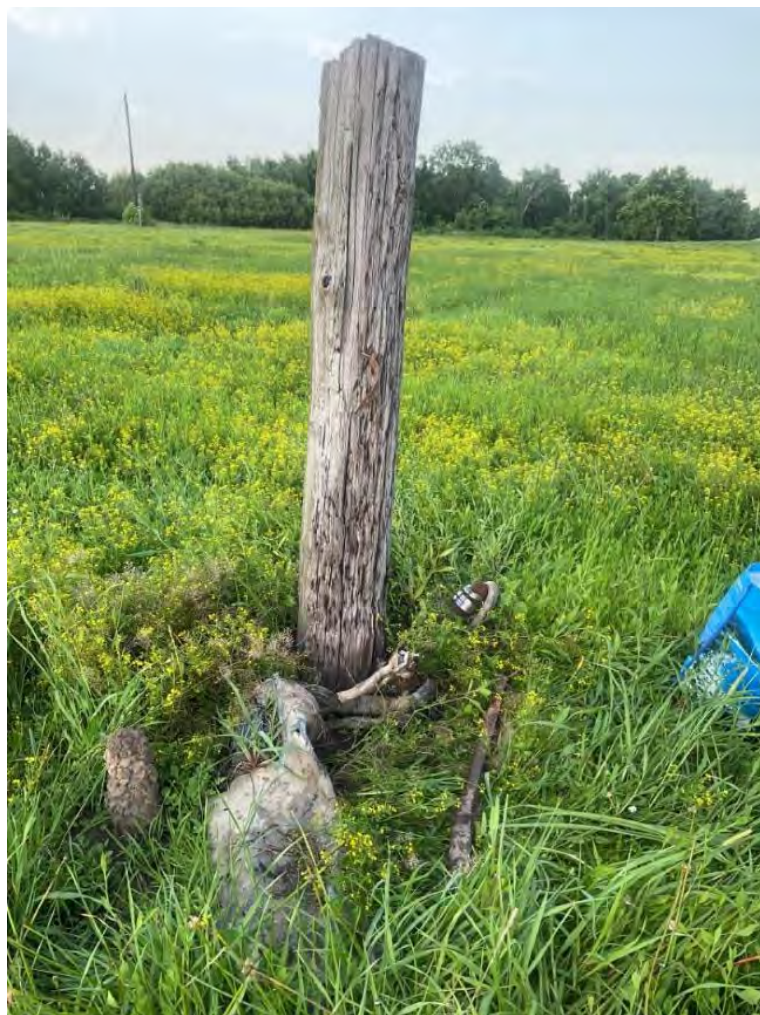
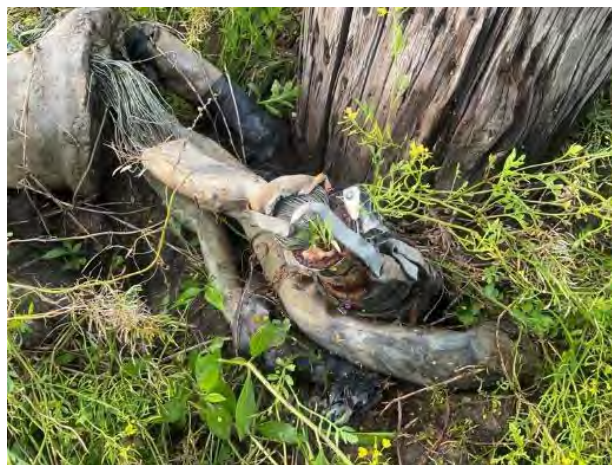
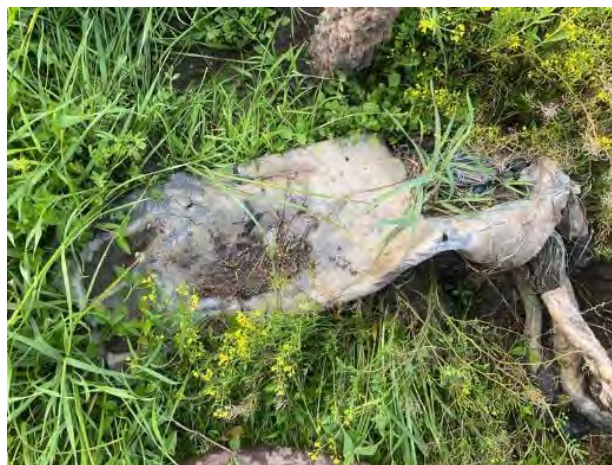
**Figure 7 Photos. Louisiana continued. Damaged and abandoned leaded splice box and collection of five leaded cables. MISS 12.3. June 2022, Donaldsonville, Louisiana.**

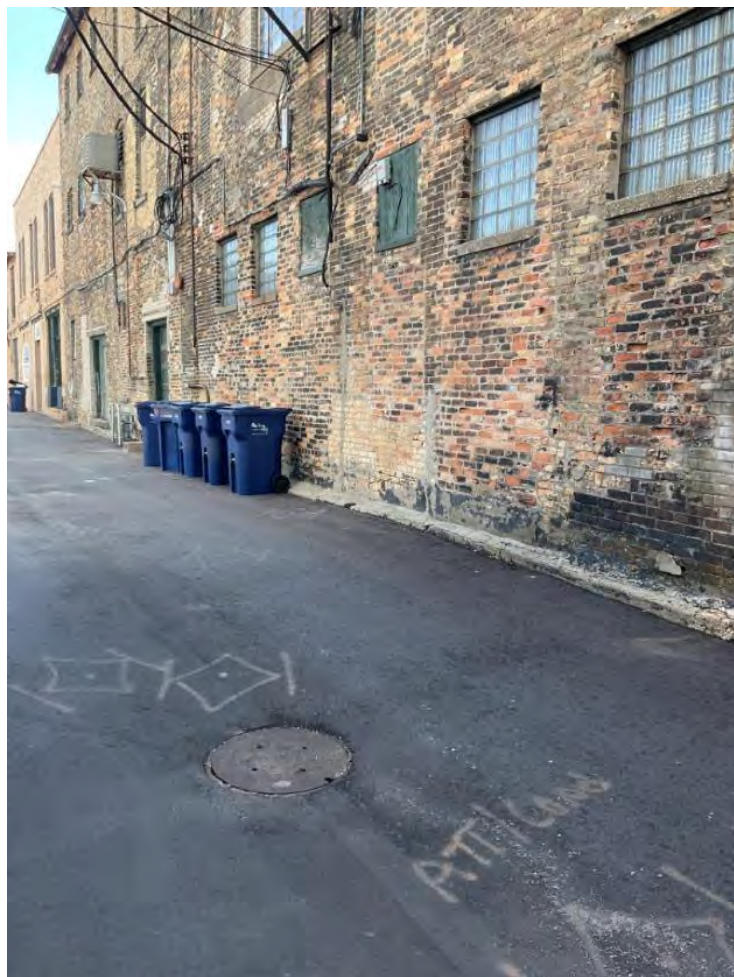
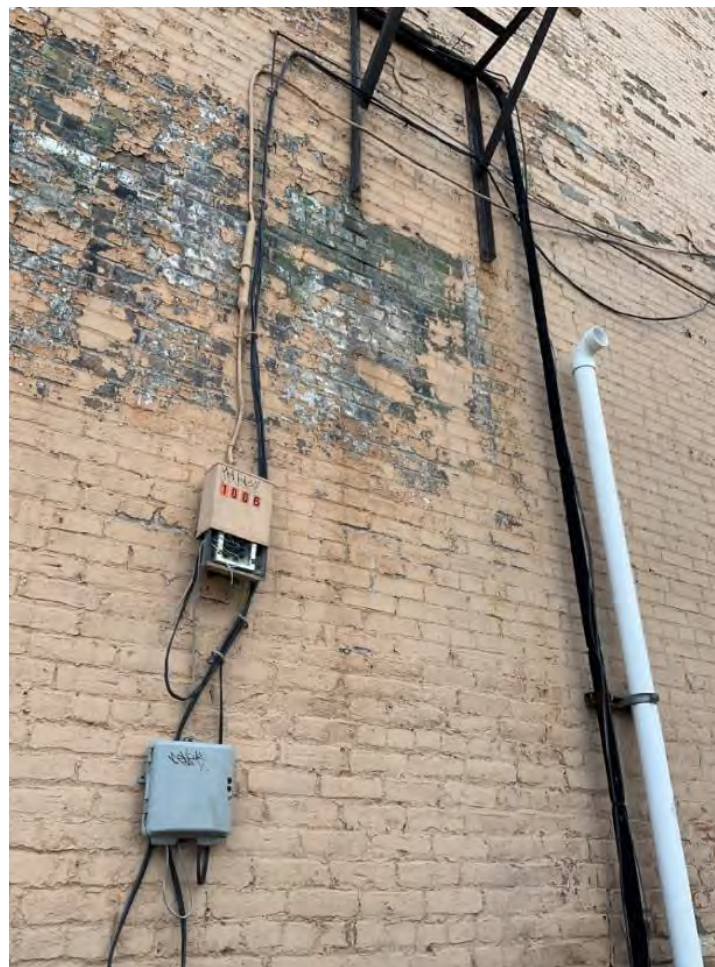
Figure 8 Photos. Michigan. Paint Markings indicating an AT&T service corridor. The leaded air test line follows these markings along the brick building shown above. July 2022, Bay City, MI.

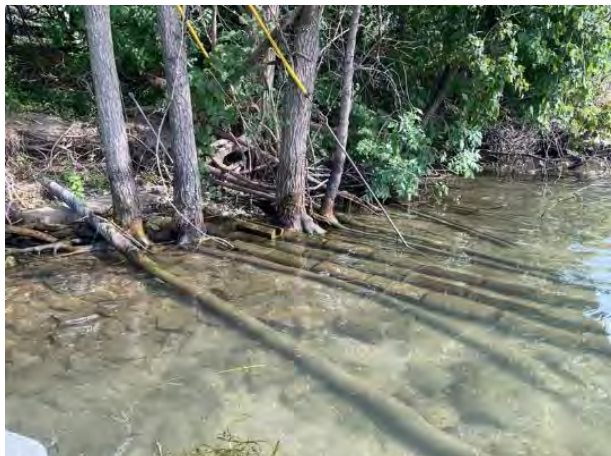
(A) Seven leaded cables in the Detroit River. DR 1. July 2022, Trenton, MI.

The only two locations in the screening areas to contain visible leaded cables were along the Detroit River. At Location DR 1, there were seven cables along the shoreline and two Bell Systems manholes near the road ([Figure 9](#)~~Figure 9~~). The other location with a single cable hanging from the bridge and going into the water was found at site DR 2. The cable was cut and clearly abandoned in place. For additional information, refer to detail in the report titled “202207727 Michigan Data Collection – Final”.

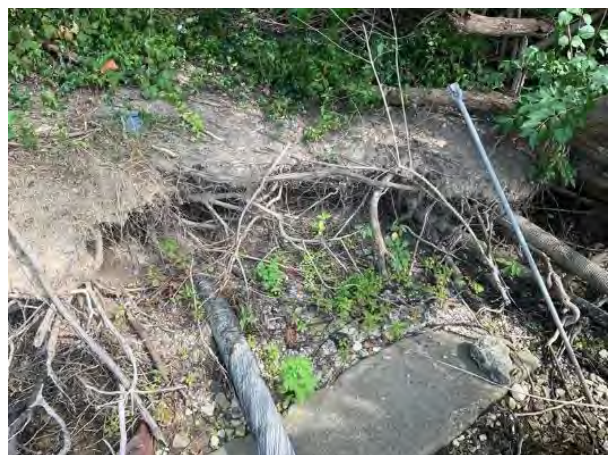
(B) Leaded cables from (A) continuing past the tree line. They are buried in the ground and run up the hill to a Bell Systems manhole. DR 1. July 2022, Trenton, MI.

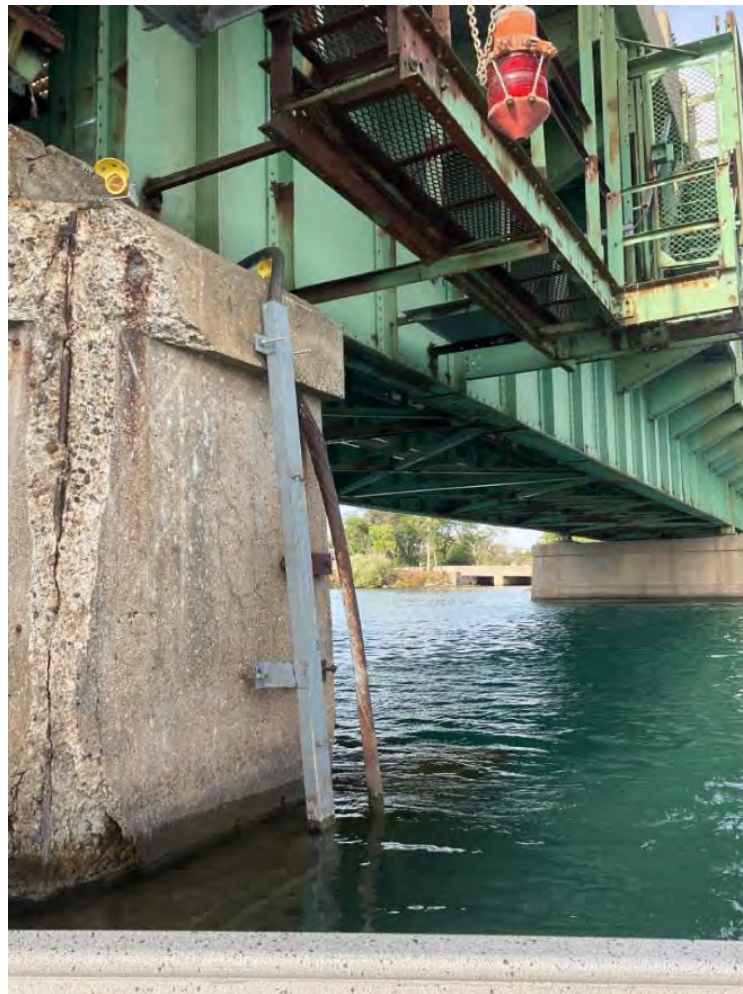
(C) Leaded cable along the Grosse Ile Parkway Bridge. The cable runs through the concrete and is cut just above the ledge. DR 2. Grosse Ile Township, MI.

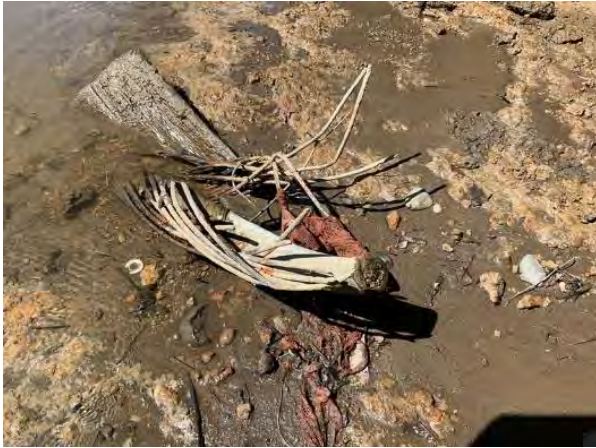
(A) Abandoned leaded cable near Ross Island. WR 1. August 2022, Portland, Oregon.

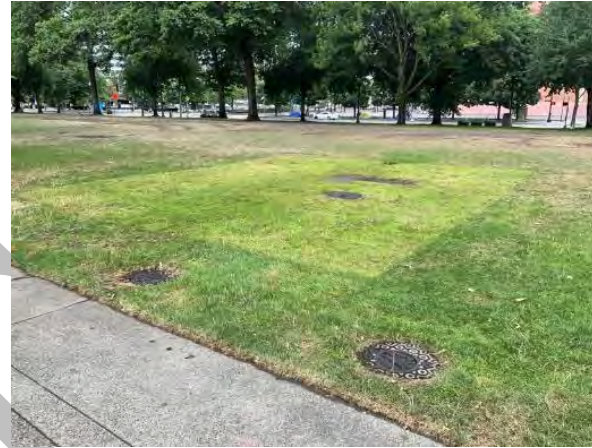
(C) Five Bell Systems manholes with vault. WR 2.2. August 2022, Portland, Oregon.

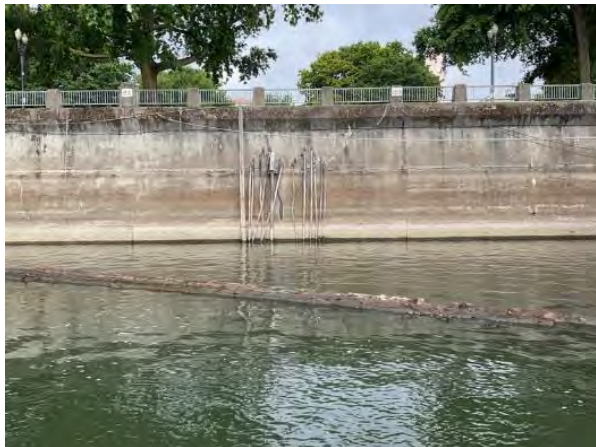
(B) Eleven cables near Maritime Museum and Waterfront Park. WR 2.2. August 2022, Portland, Oregon.

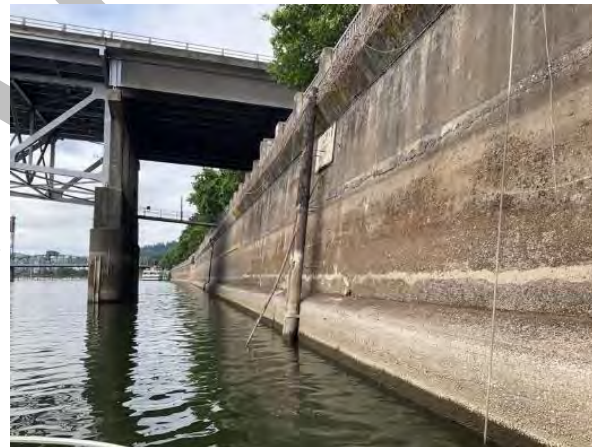
(D) Smaller leaded cable below Western Union Telecom Co. Sign. WR 3. August 2022, Portland, Oregon.

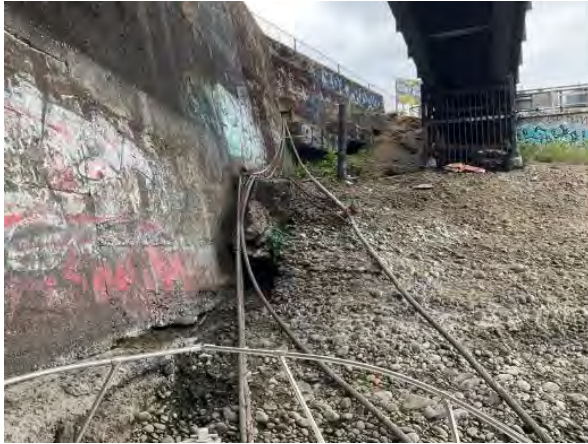
(E) North Steel Bridge cables. WR 6. August 2022, Portland, Oregon.

There were seven locations along the Willamette River in Oregon. Nine points of interest were recorded along the Willamette River containing visible leaded submarine cables in varied conditions. At low tide, with lower river levels, WR 1 can be seen on the shoreline protruding from the riverbed. This is a cut and abandoned leaded cable on the east bank of the Willamette River near Ross Island ([Figure 10](#)~~Figure 10~~). Our team spoke with a homeless man living on a nearby boat who mentioned the cables being visible at different times during the year. The same location had a newer cut telecommunications cable which also had a thin lead sheathing. Near the Oregon Maritime Museum and Waterfront Park Trail, WR 2.2 contains eleven leaded cables protruding from the wall and running into the Willamette River. The associated site WR 2, just over the railing has five Bell Systems manholes and what appears to be a large access vault ([Figure 10](#)~~Figure 10~~). Site WR 3 had a much older and smaller leaded cable running just below an old wooden, Western Union Telcom Co. Sign just below the Morrison Bridge ([Figure 10](#)~~Figure 10~~). Underneath the West Burnside Bridge, site WR 5.1 had four leaded cables that went submarine where the bridge opens. At the North Steel Bridge, point of interest, WR 6, is a collection of four leaded cables that were observed chained up to the concrete footings, until going inside the footings near the street ([Figure 11](#)~~Figure 11~~). These were not visible at the southwest end of the

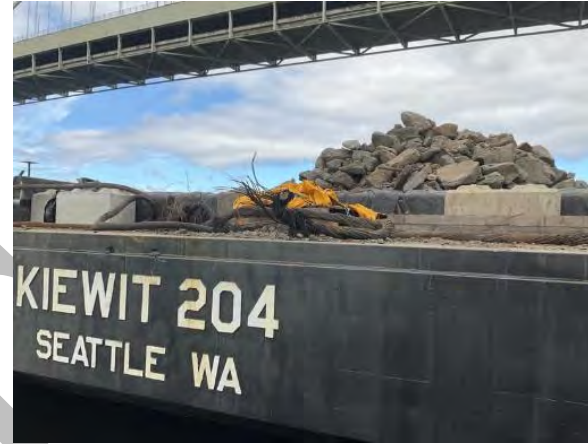
(G) Active construction site. Leaded cable. Kiewit 204. WR 8. August 2022, Portland, Oregon.

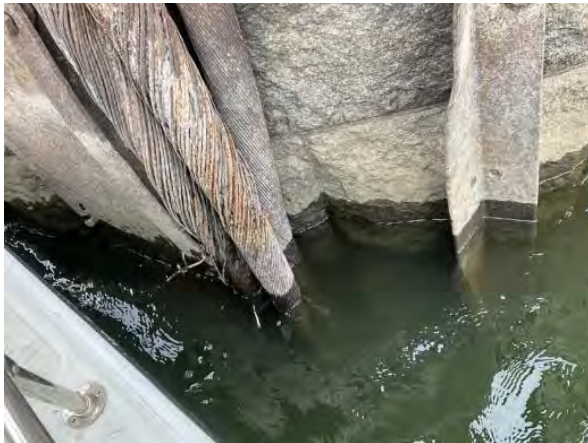
(F) NW Broadway Bridge cables. WR 7. August 2022, Portland, Oregon.

bridge, which is also the northernmost end of Portland's Waterfront Park Trail and Greenway. As such, these cables are likely hidden within new development. The NW Broadway Bridge at point WR 7 contained a collection of six leaded cables. These cables go submarine at the point the bridge opens. Some of these cables have been struck and damaged by, passing boats, or floating debris in the river ([Figure 11](#)~~Figure 11~~). The final screened location WR 8, was an active construction site along the waterfront. There was limited access to the point of interest provided by the WSJ, however, the team observed a coiled up leaded cable on the barge. After a brief discussion with the foreman, it was learned that this cable may have been pulled from the Abernathy Bridge south of Ross Island. This was not a location the team had time to investigate during this trip refer to [Figure 11](#)~~Figure 11~~.

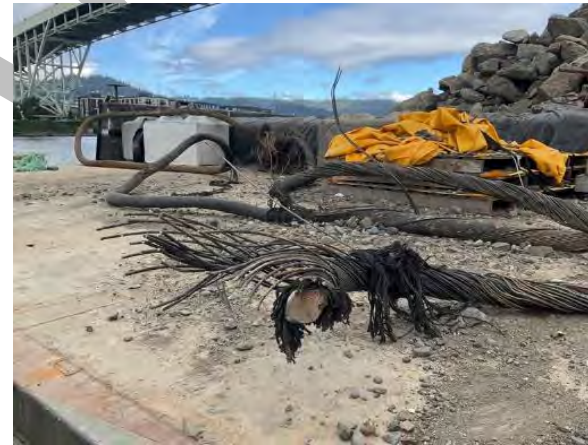
(H) Possible Abernathy Bridge cable. WR 8. August 2022, Portland, Oregon.

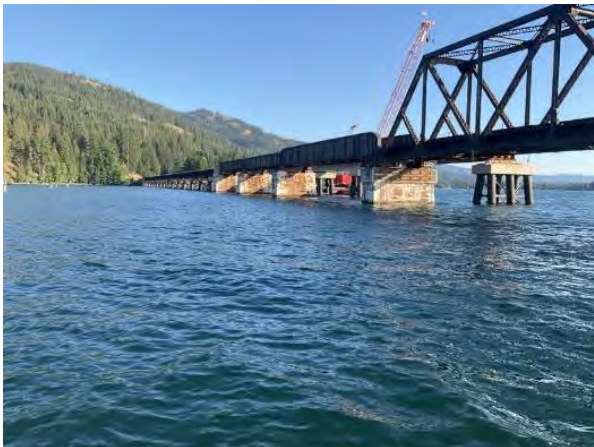
(A) Lake Pend Oreille, ID Railroad Bridge. August 2022.

Overall, our findings in Idaho showed few visible leaded cables with a high potential of buried cables in areas where signs and Bell Systems manholes were observed. The cables found off the old railroad bridge have been cut and left near the base of the bridge. They are clearly abandoned and should be removed. Further investigation into the status of these cables and how to move forward with the next steps of removing the remnants is suggested.

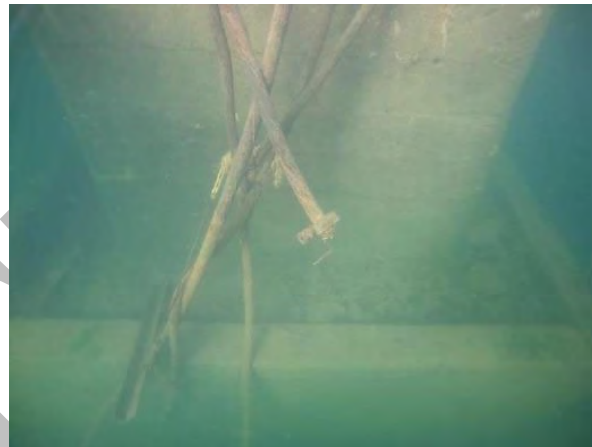
(B) Photo. Leaded cables just below the surface. Site LP 4.1. August 2022, Lake Pend Oreille, ID.

There was one point with visible leaded cables in Idaho that was found in the Lake Pend Oreille on the southeast end of the railroad bridge near Highway 95. This collection of cables was cut and left in place at the base of the bridge. At the time of our most recent visit, there was construction work and a large barge over the location of the cables which are tangled underwater. Refer to [Figure 12](#) ~~Figure 12~~ and [Figure 13](#) ~~Figure 13~~ for Lake Pend Oreille photos.

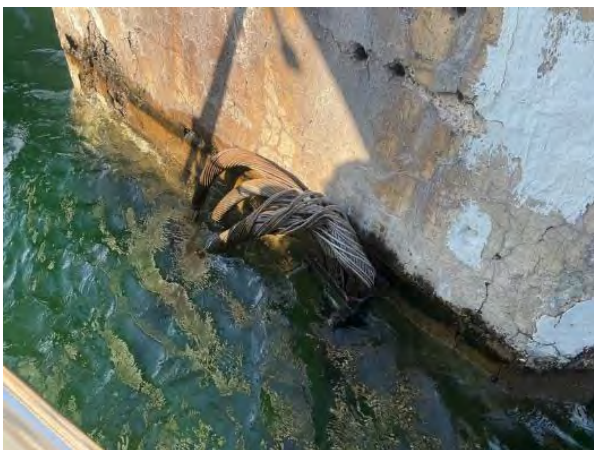
(C) Leaded cables cut and hanging from bridge. Site LP 4.1. August 2022, Lake Pend Oreille, ID.

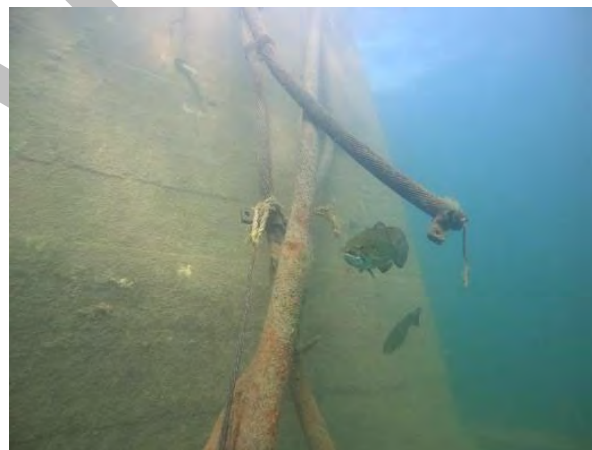
(D) Bare lead (top right). Cut end, near fish (mid-left). Site LP 4.1. August 2022, Lake Pend Oreille, ID.

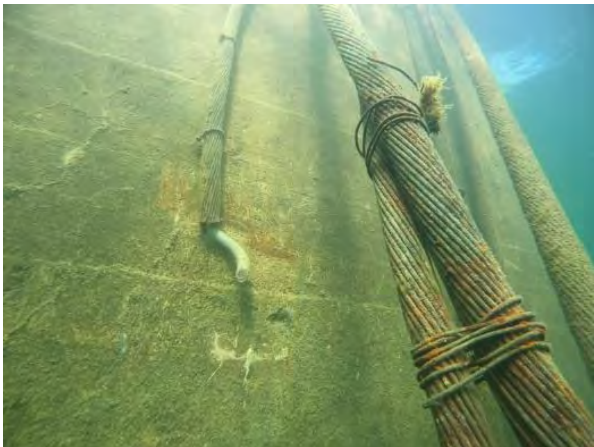
(E) Close up of cut, bare leaded cable underwater. Site LP 4.1. August 2022, Lake Pend Oreille, ID.

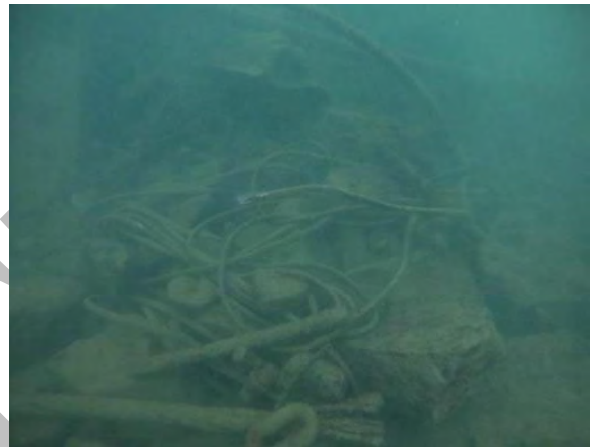
(F) Leaded cables abandoned and coiled below the surface. Site LP 4.1. August 2022, Lake Pend Oreille, ID.

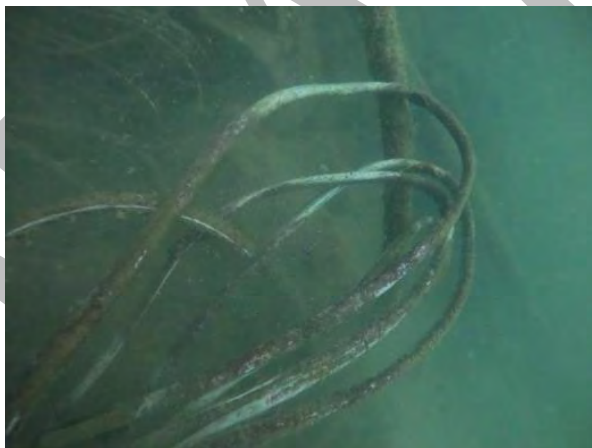
(G) Close up of bare lead from abandoned cables. Site LP 4.1. August 2022, Lake Pend Oreille, ID.

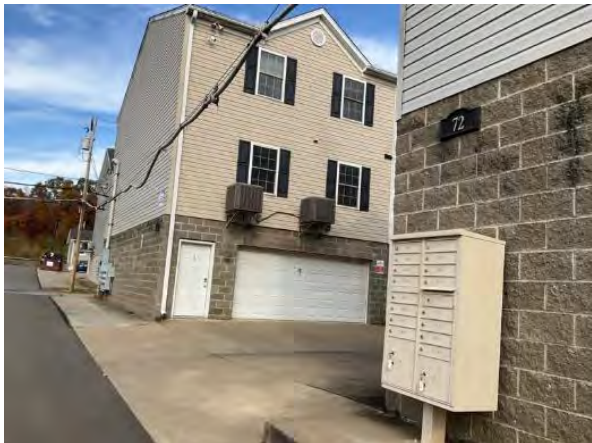
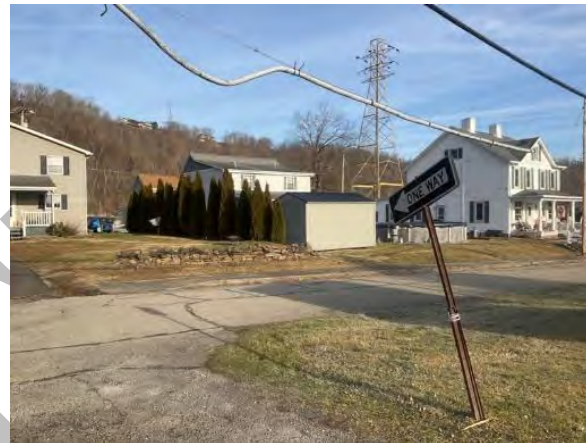
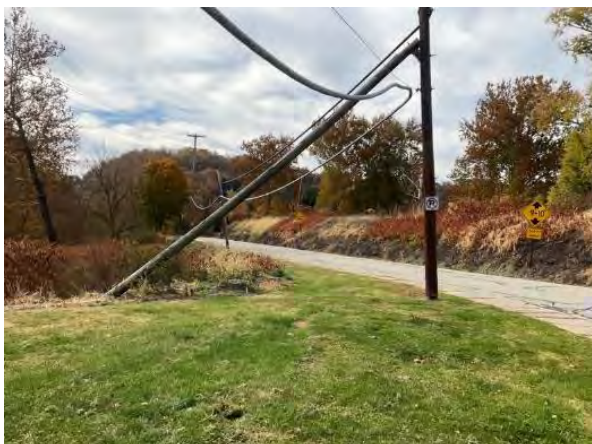
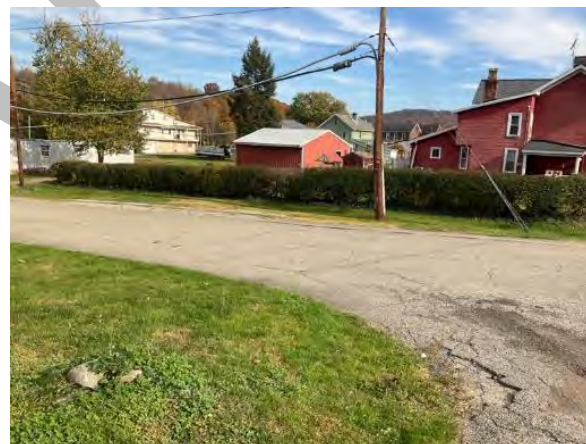
Figure 14. Points along the Overhead leaded telecommunications cables that runs approximately 0.9 miles through California Township and Coal Center, PA. CT 6, CT 8, CT 11 (February 2023), and CT 12. October 2022. California Township and Coal Center.

This is the first location during the project where extensive overhead, leaded cables were documented and observed. The areas of interest within California and Coal Center, are adjacent and to the west of the Penn West California University, an area that was notably less affluent. Thirteen points of interest were recorded, covering an approximate distance of .9 miles worth of visible, overhead leaded cable ([Figure 14](#)~~Figure 14~~). This is an estimation following the streets, and not an exact calculation of length. This cable starts on 2<sup>nd</sup> Street, across from campus and runs through California to the edge of Coal Center where it appears to terminate a few blocks uphill from the Monongahela River's edge. The cable crosses overhead at parks, senior care centers, and lots where kids were playing. Locals in the area suggested that other adjacent townships may have similar overhead cables that should be explored. Recommend further investigations.

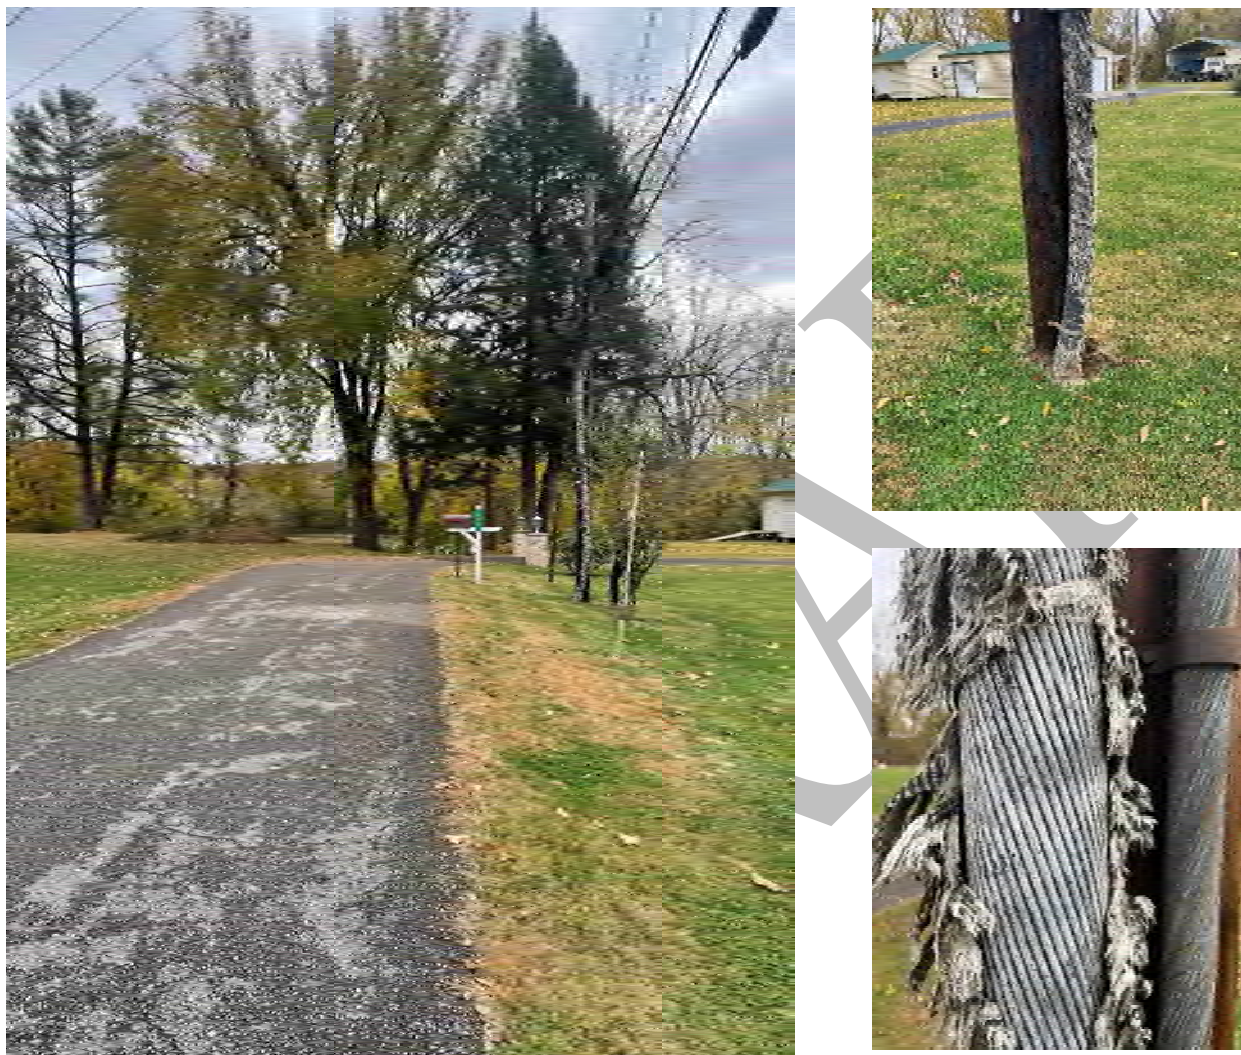
Figure 15. Photos taken in West Virginia. Site for the Old Pliny Ferry Crossing at Frasier's Bottom. Two bare leaded cables were observed at the end of Ferry Lane. KR 1.3. October 2022, Pliny, West Virginia.

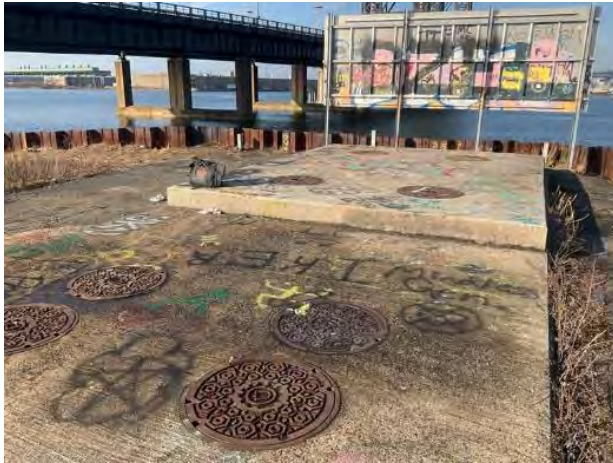
(A) Large vault with eight Bell Systems manholes on the Hackensack River. Looking towards South Kearny. January 2023, West Side, New Jersey.

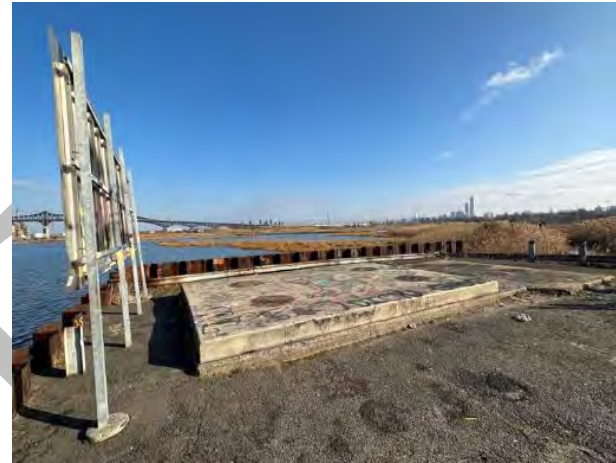
(C) Vault area looking towards Lincoln Park Wetlands & Nature Trail. January 2023, West Side, New Jersey.

Figure 16. Photos. New Jersey. (A-D) Cable locations near Lincoln Park Wetlands & Nature Trail. Hackensack 2. January 2023, West Side, New Jersey.

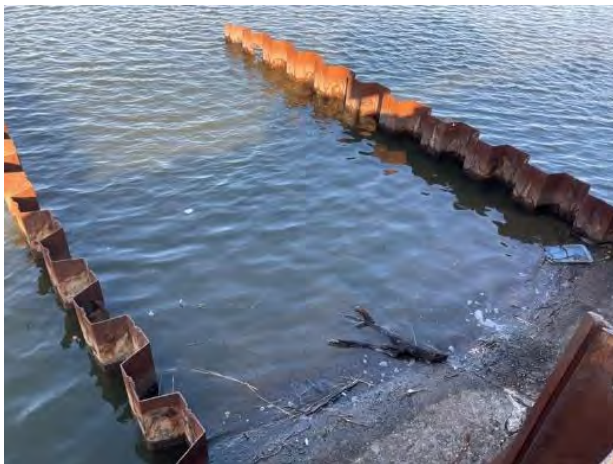
(B) Cable landing area covered with concrete. Area is below the sign in (D).

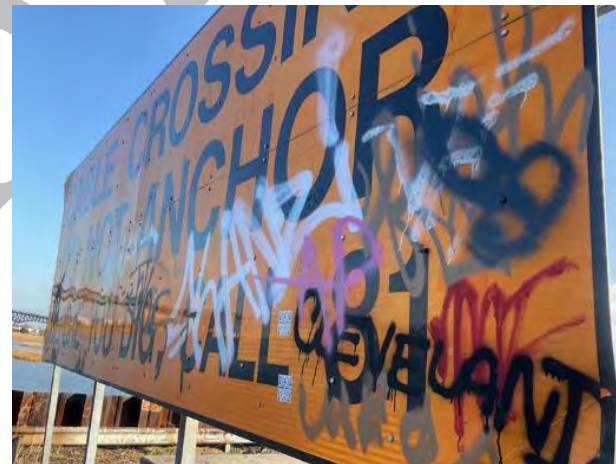
(D) Cable Crossing Sign. January 2023, West Side, New Jersey.

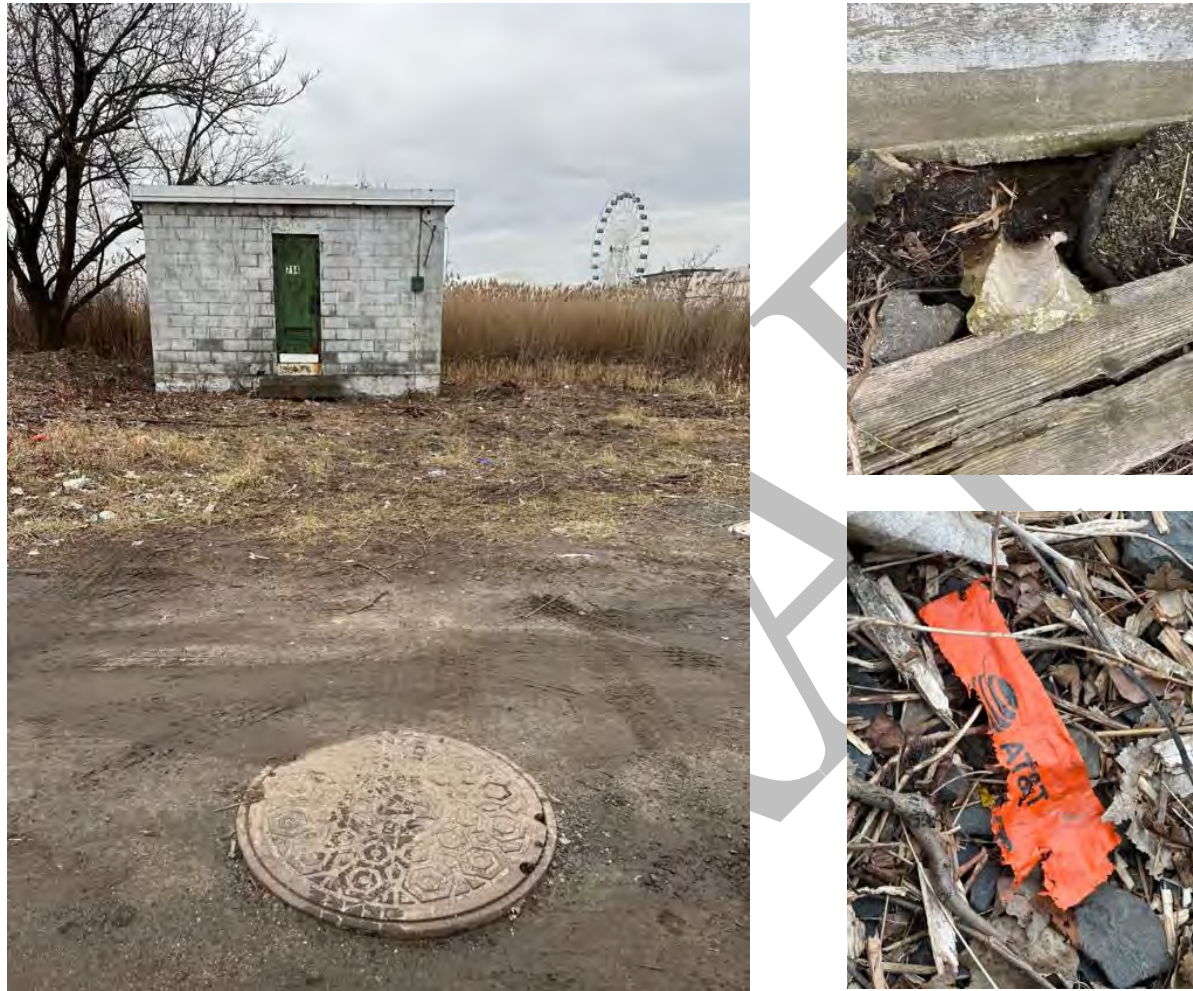
Figure 17. Photos. New Jersey continued. Largely abandoned area around the Meadowlands. Old Bell Systems manhole and utility building (Left). Concrete casing that would have laid on top of the old leaded cable. This is like those found on the Detroit River, Location 1 (Upper Right). Newer AT&T flagging found a few feet away from the building. Hackensack 3.2. January 2023, Meadowlands, New Jersey.
